**RUSSIAN RIVER STREAM CROSSING INVENTORY AND FISH PASSAGE  
EVALUATION**

**FINAL REPORT**

**Ross N. Taylor, Thomas D. Grey, Anabel L. Knoche, and Michael Love**

**March 31, 2003**

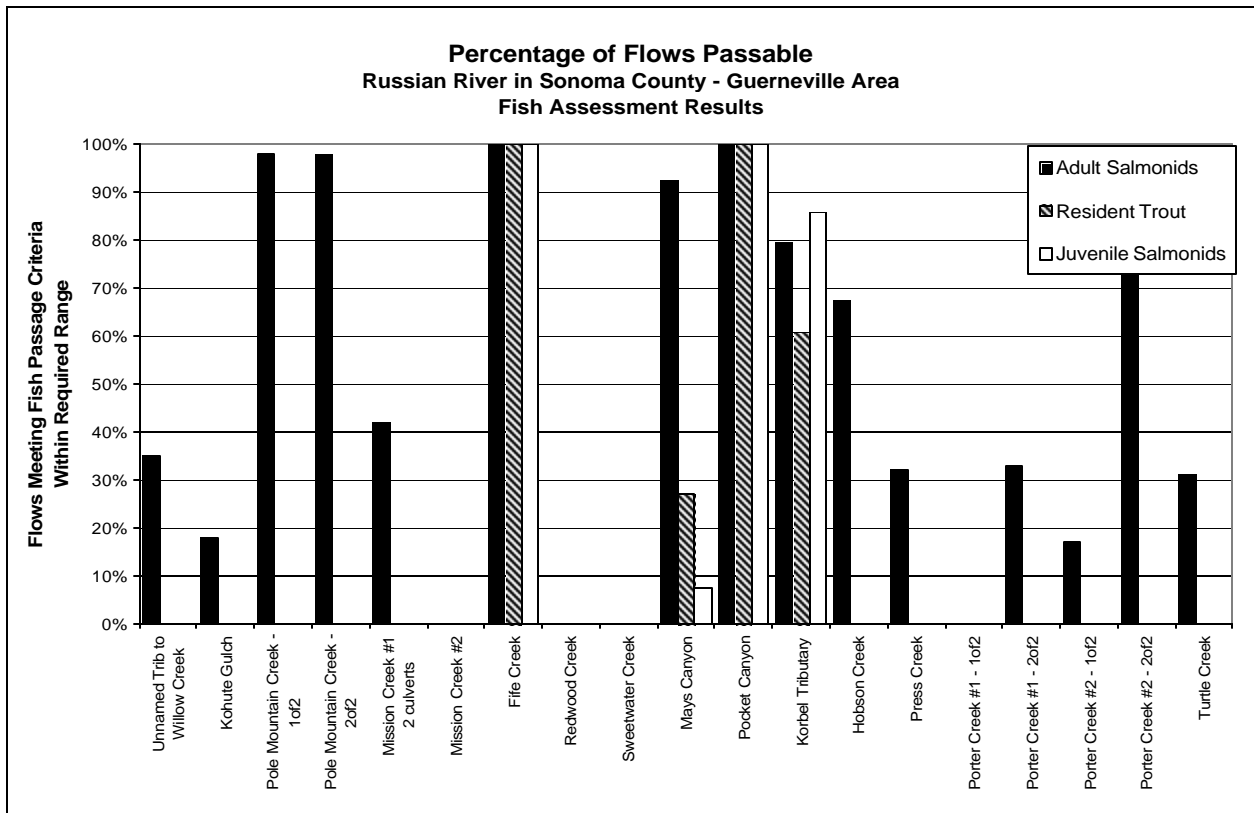
Figure 8. Percent passable as estimated by the Green-Gray-Red evaluation filter and FishXing for 16 Sonoma County stream crossings within the Guerneville area, by three groups of life-stages.

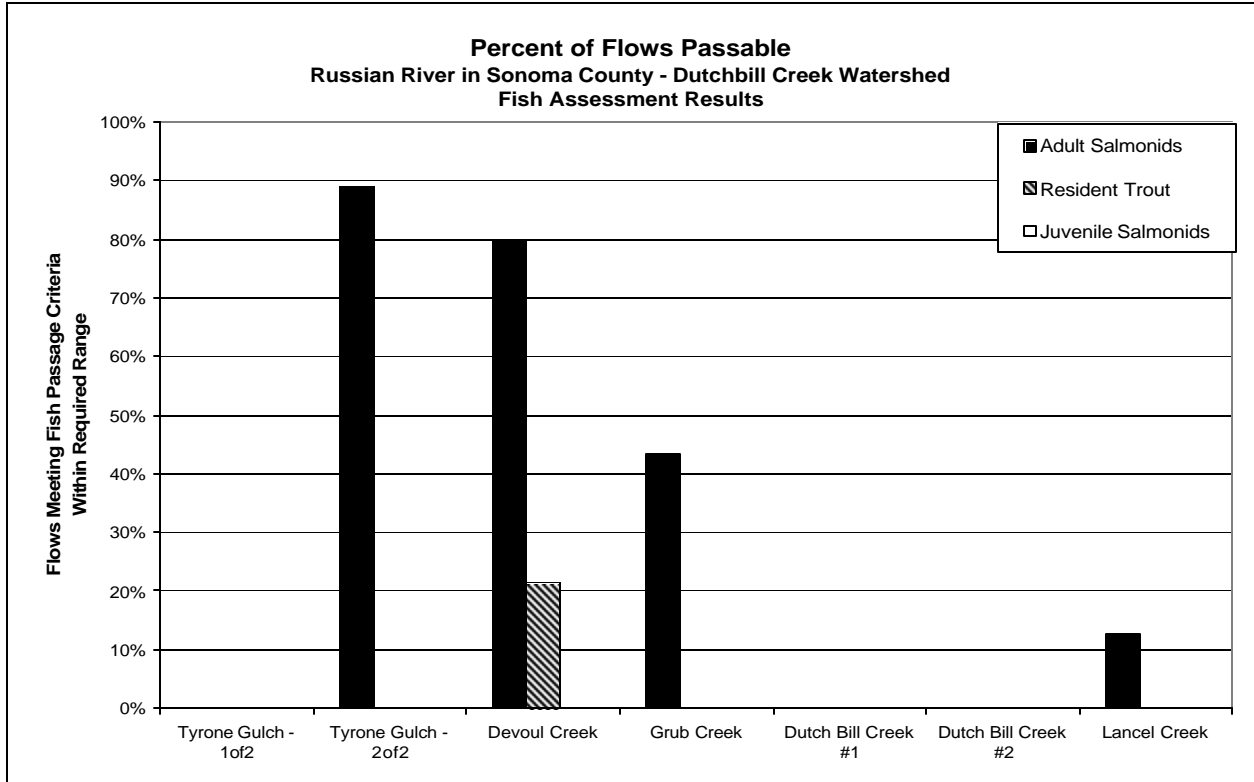
Figure 9. Percent passable as estimated by the Green-Gray-Red evaluation filter and FishXing for six Sonoma County stream crossings within the Dutch Bill Creek sub-basin, by three groups of life-stages.

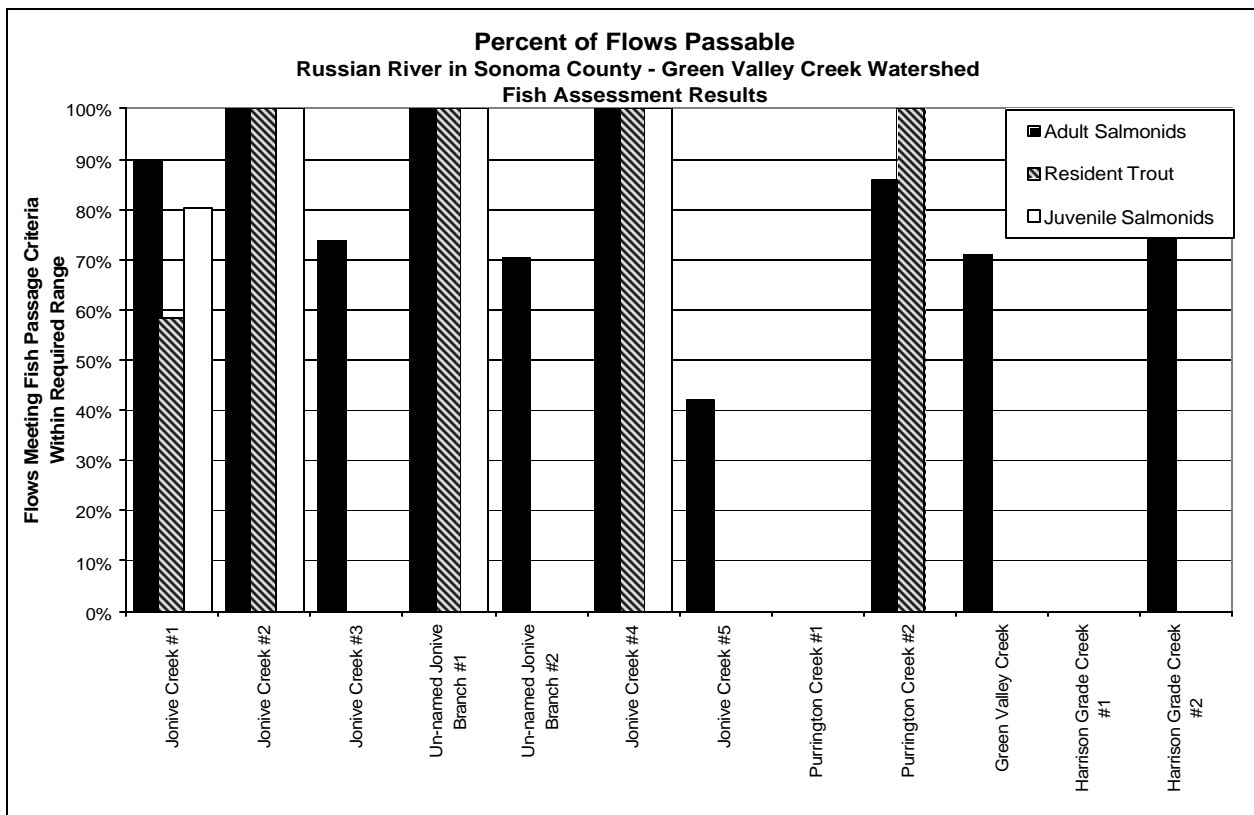
Figure 10. Percent passable as estimated by the Green-Gray-Red evaluation filter and FishXing for 12 Sonoma County stream crossings within the Green Valley Creek sub-basin, by three groups of life-stages.

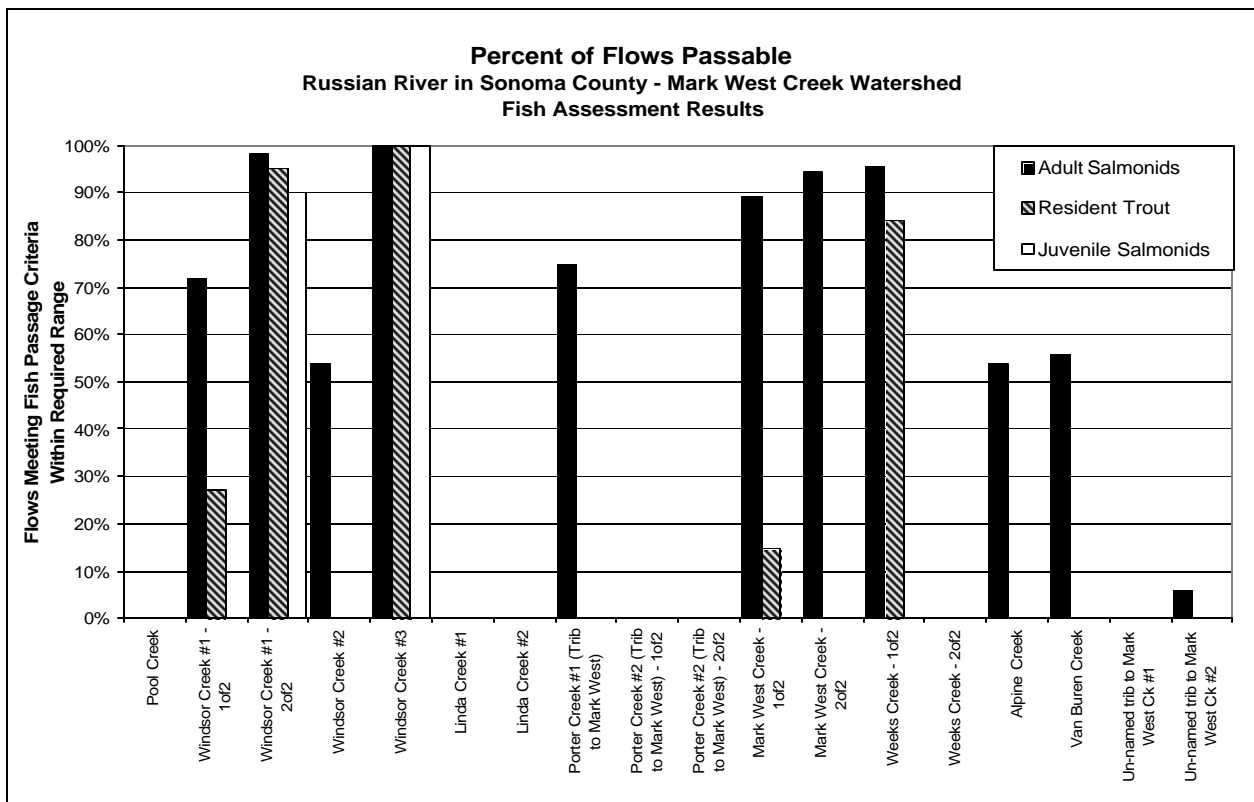
Figure 11. Percent passable as estimated by the Green-Gray-Red evaluation filter and FishXing for 15 Sonoma County stream crossings within the Mark West Creek sub-basin, by three groups of life-stages.

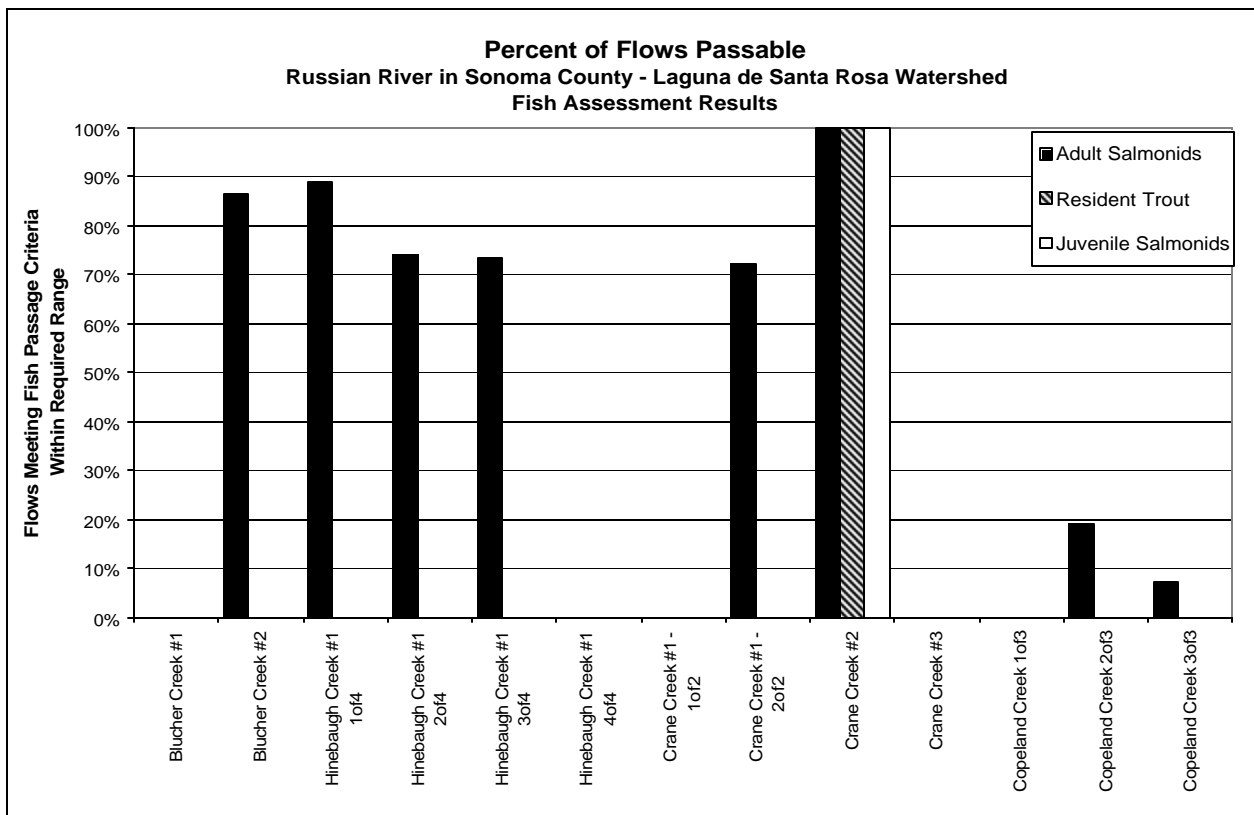
Figure 12. Percent passable as estimated by the Green-Gray-Red evaluation filter and FishXing for seven Sonoma County stream crossings within the Laguna de Santa Rosa sub-basin, by three groups of life-stages.

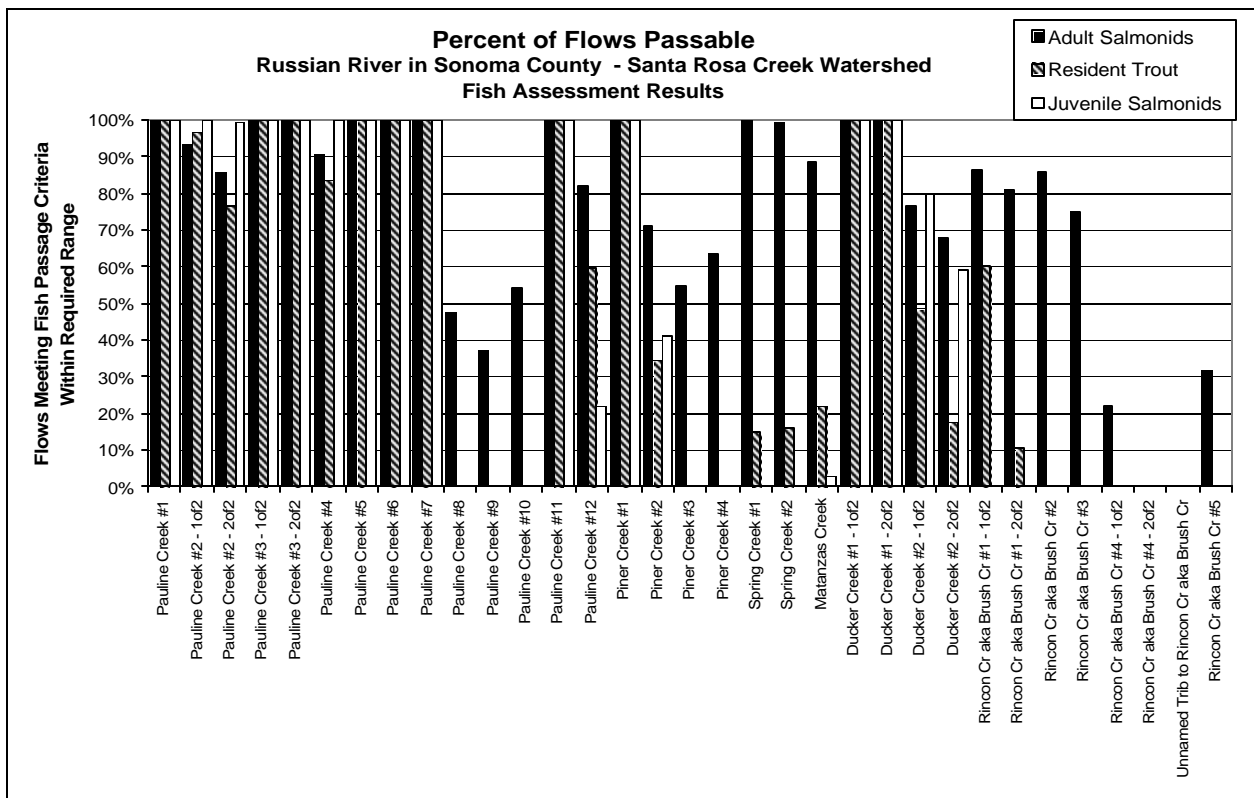
Figure 13. Percent passable as estimated by the Green-Gray-Red evaluation filter and FishXing for 27 Sonoma County stream crossings within the Santa Rosa Creek sub-basin, by three groups of life-stages.

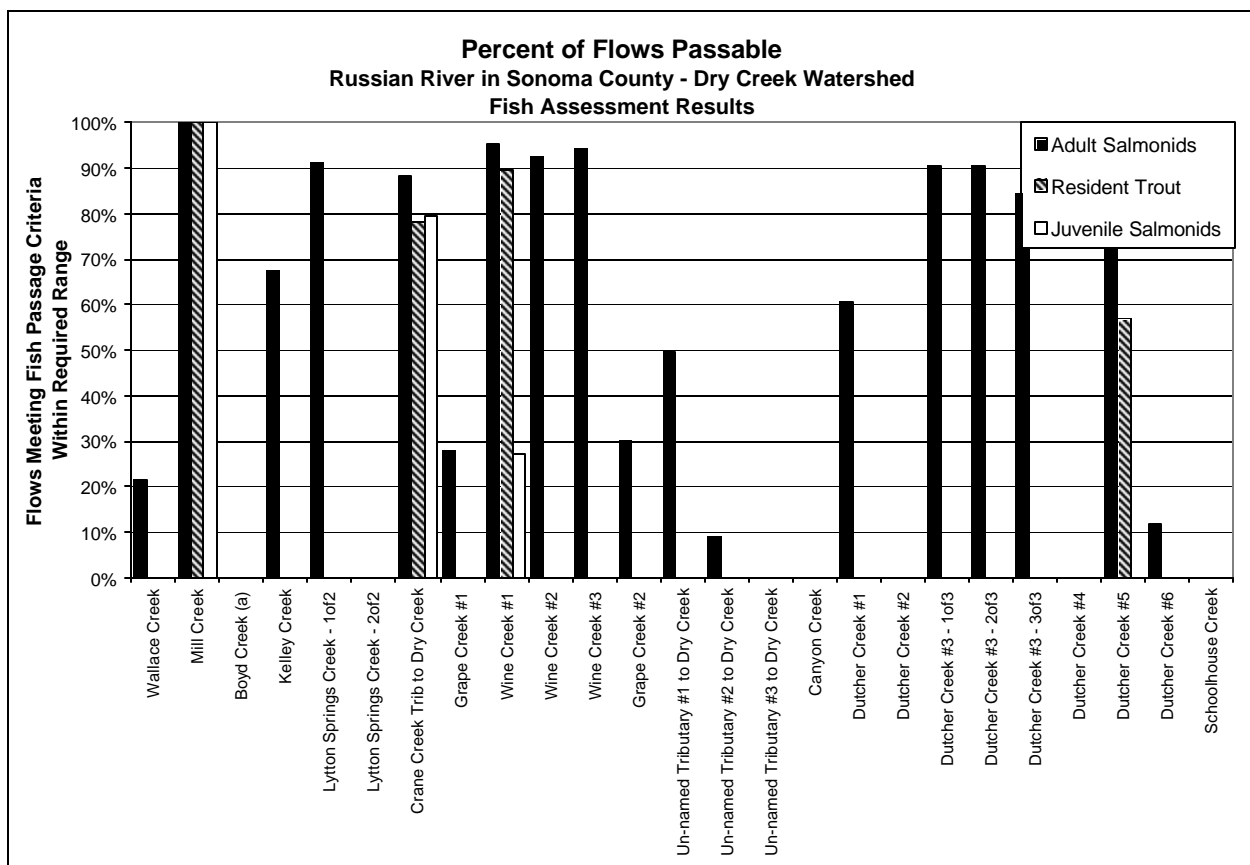
Figure 14. Percent passable as estimated by the Green-Gray-Red evaluation filter and FishXing for 22 Sonoma County stream crossings within the Dry Creek sub-basin, by three groups of life-stages.

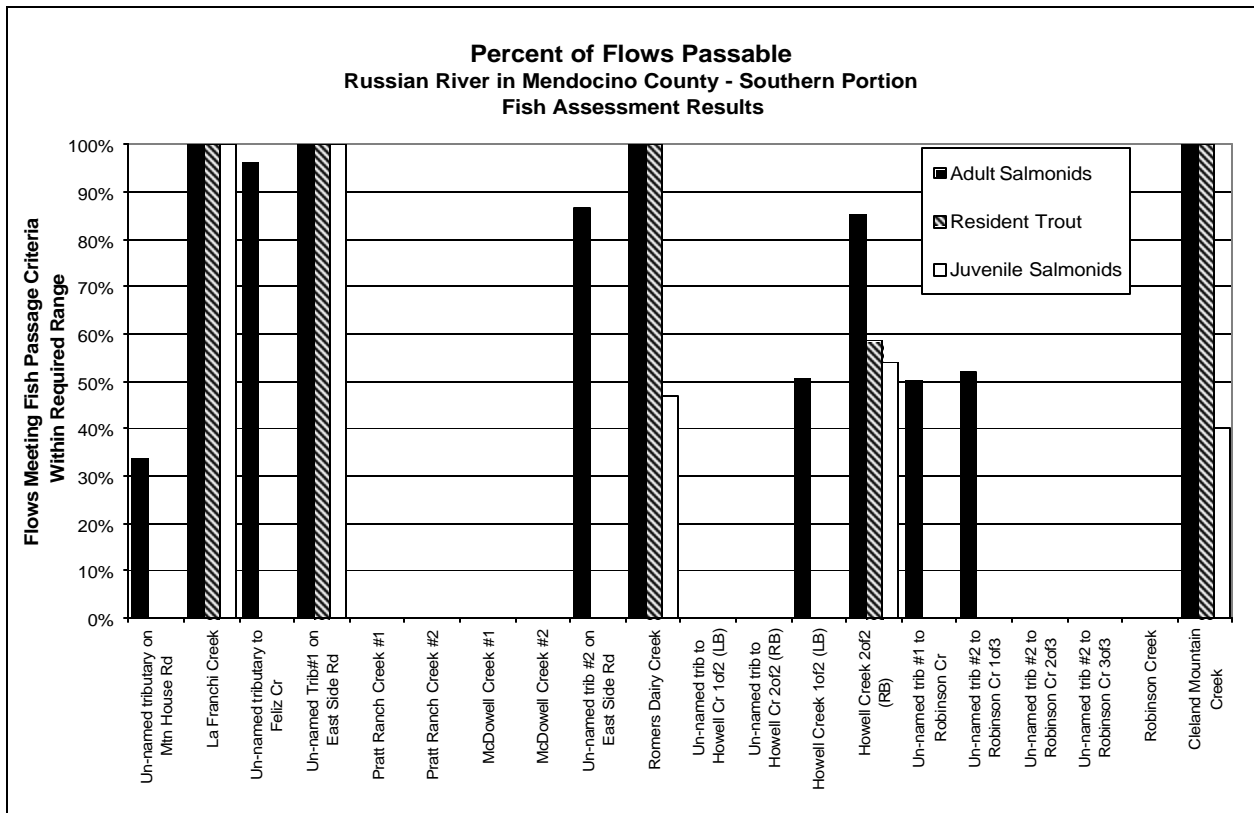
Figure 15. Percent passable as estimated by the Green-Gray-Red evaluation filter and FishXing for 16 Mendocino Co. stream crossings within the southern portion of Russian basin, by three groups of life-stages.

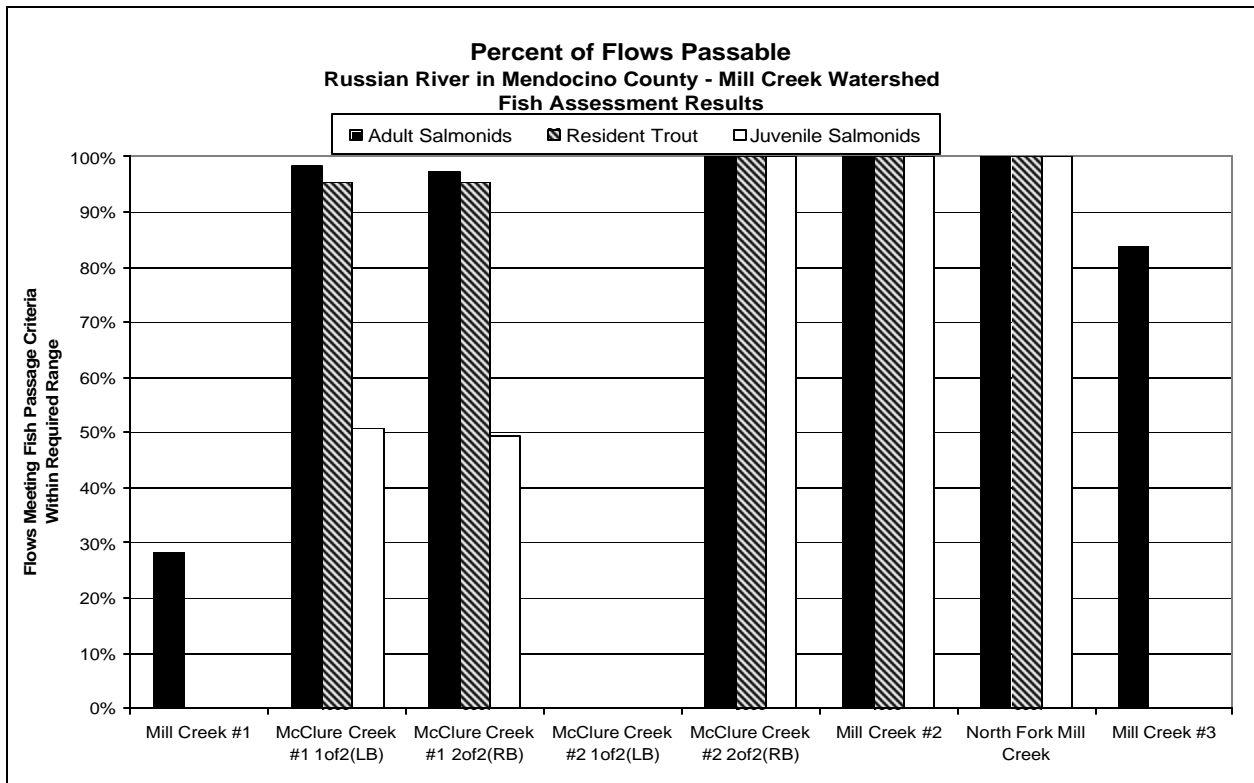
Figure 16. Percent passable as estimated by the Green-Gray-Red evaluation filter and FishXing for six Mendocino County stream crossings within the Mill Creek sub-basin, by three groups of life-stages.

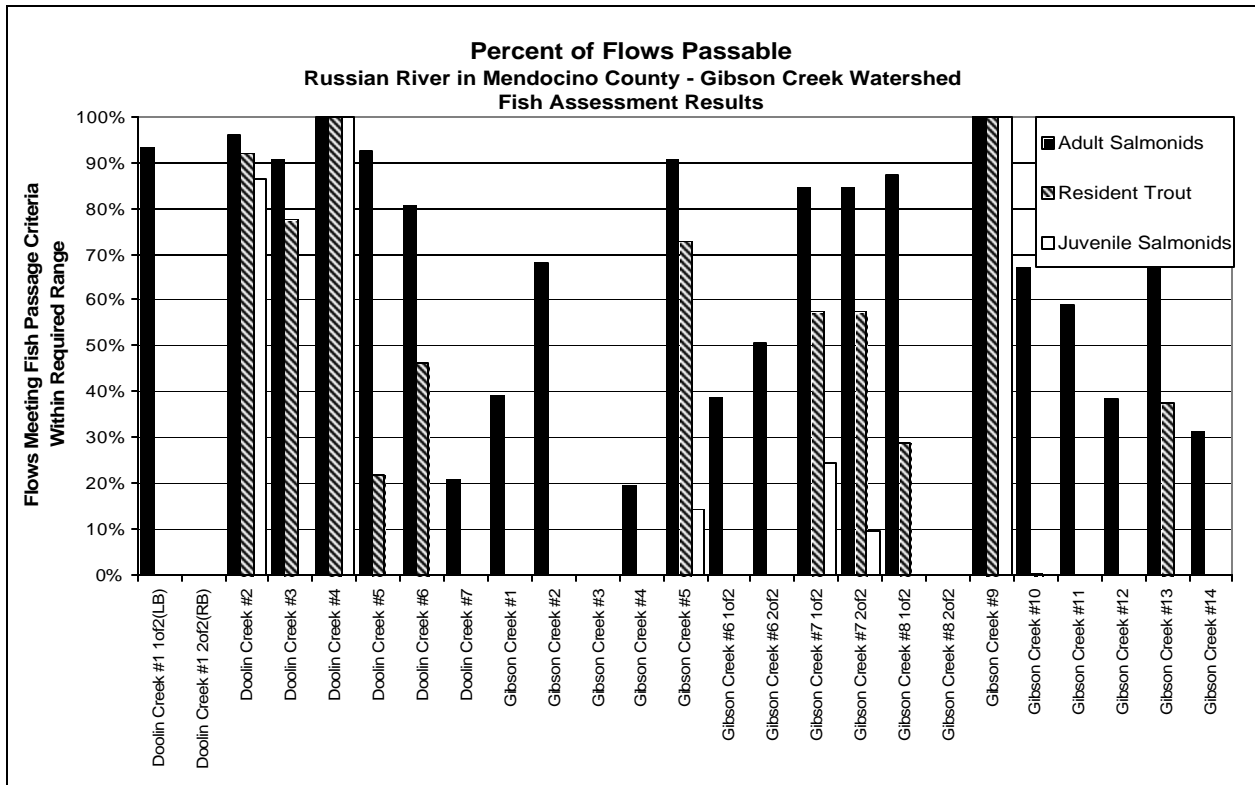
Figure 17. Percent passable as estimated by the Green-Gray-Red evaluation filter and FishXing for 21 Mendocino County stream crossings within the Gibson Creek sub-basin, by three groups of life-stages.

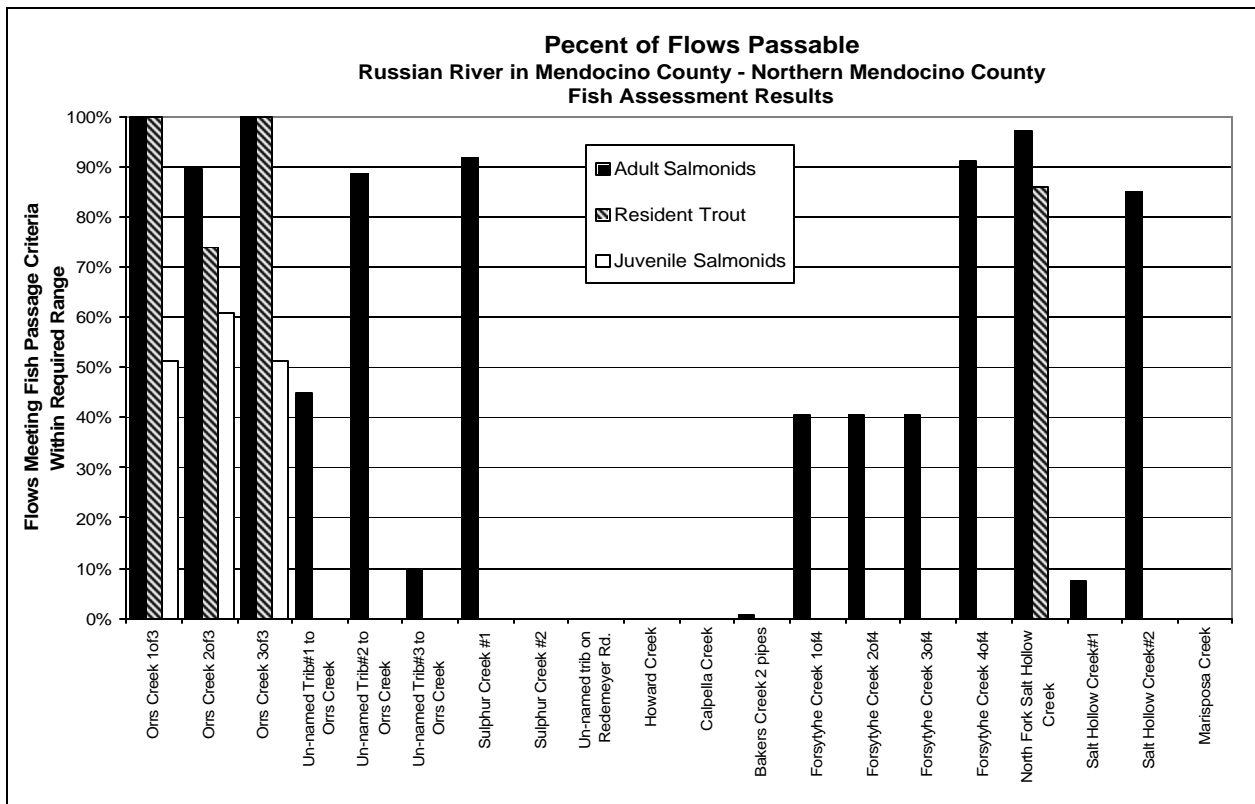
Figure 18. Percent passable as estimated by the Green-Gray-Red evaluation filter and FishXing for 15 Mendocino County stream crossings within the northern portion of Russian River basin, by three groups of life-stages.
