DEPARTMENT OF FISH AND GAME  
STREAM SURVEY

NAME.....Ham Canyon Creek.....COUNTY.....Mendocino.....  
 STREAM SECTION.....FROM.....mouth.....TO...extreme headwaters.....LENGTH.....3.8 MI.  
 TRIBUTARY TO.....Rancheria Creek.....TWP....14N...R..14W....SEC....30.....  
 OTHER NAMES.....unknown.....RIVER SYSTEM.....Navarro River.....  
 SOURCES OF DATA....personal survey and information from local residents and loggers.....

HAM CANYON CREEK  
P-2 Mendocino County

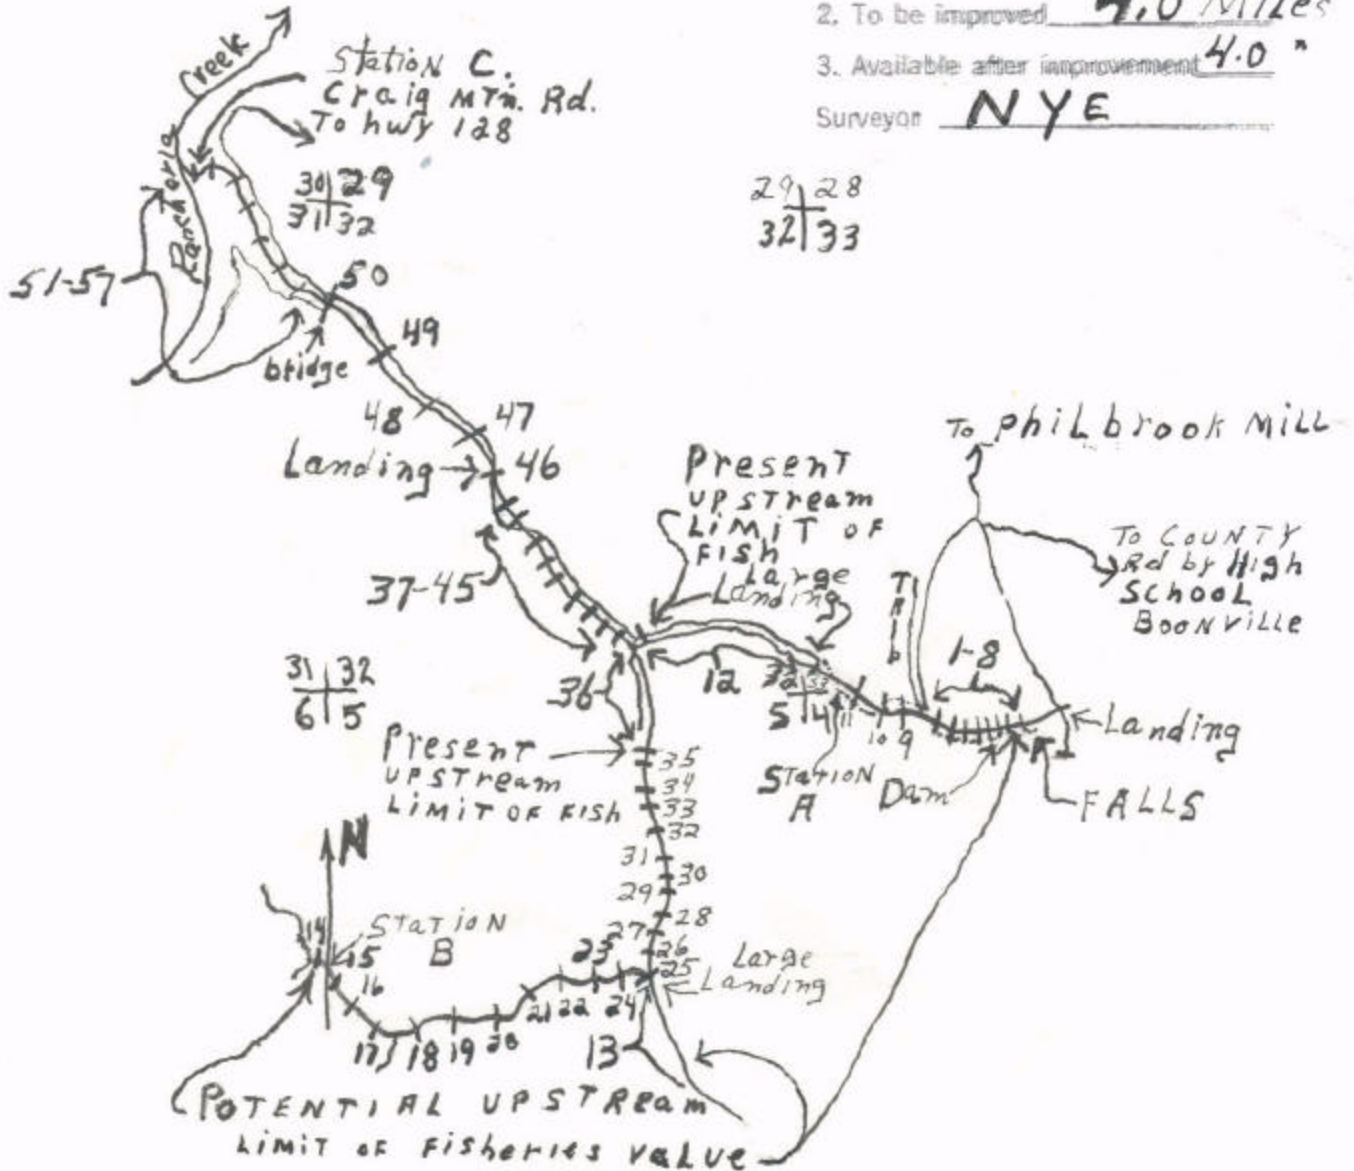
1. - (Falls - 10 x 8 x 9' - 98%)
2. (12)
3. dam (15 x 25 x 6')
4. (78 x 3 x 2 - 98%)
5. (54' x 8 x 5 - 95%)
6. (6)
7. (4)
8. (20)
9. (42 x 8 x 3 - 98%)
10. (18)

11. (80 x 12 x 8 - 99%)
12. (.35 mile x 30 x 5 - 99%)
13. (800 ft x 30 x 4' - 99%)
14. (50 x 15 x 4) (98%)
15. (30)
16. (70 x 20 x 4 - 98%)
17. (30)
18. (50 x 12 x 6 - 99%)

19. (30)
20. (10)
21. (10)
22. (50 x 15 x 3 - 98%)
23. (20)
24. (20)
25. (20)
26. (30)
27. (100 x 10 x 3) (-98%)
28. (12)
29. (15)
30. (15)
31. (10)
32. (100 x 8 x 5 - 98%)

33. (20)
34. (10)
35. (15)
36. (1,050 x 30 x 4 - 98%)
37. (500 x 40 x 5 - 98%)
38. (200 x 30 x 6 - 95%)
39. (300 x 35 x 5 - 98%)
40. (100 x 20 x 4 - 95%)
41. (50 x 25 x 6 + 98%)

42. (200 x 75 x 7 - 98%)
43. (75 x 20 x 5 - 90%)
44. (20) - 20w x 3h - Dam
45. (60 x 30 x 10 - 95%)
46. (20) dam.
47. (240 x 60 x 10 - 95%)
48. (200 x 60 x 8 - 95%)

49. (25w x 4h) Dam
50. (70 x 30 x 6 - 95%) Bridge
51. (18)
52. (20)
53. (60 x 30 x 7 - 98%)
54. (80 x 25 x 17 - 0%) 12' Basin S.I.
55. (40) x 20 x 25 - 96% } 20' Basin S.I.

56. (50 x 20 x 25 - 30%) } 20' Basin S.I.
57. (6)

Add 3% For debris between Jams NOT LISTED

1. Now satisfactory for SH & SS 0 Miles
2. To be improved 4.0 Miles
3. Available after improvement 4.0 "
