# Geomorphic Processes and Aquatic Habitat in the Redwood Creek Basin, Northwestern California

# History, Causes, and Significance of Changes in the Channel Geometry of Redwood Creek, Northwestern California, 1936 to 1982

U.S. GEOLOGICAL SURVEY PROFESSIONAL PAPER 1454-N

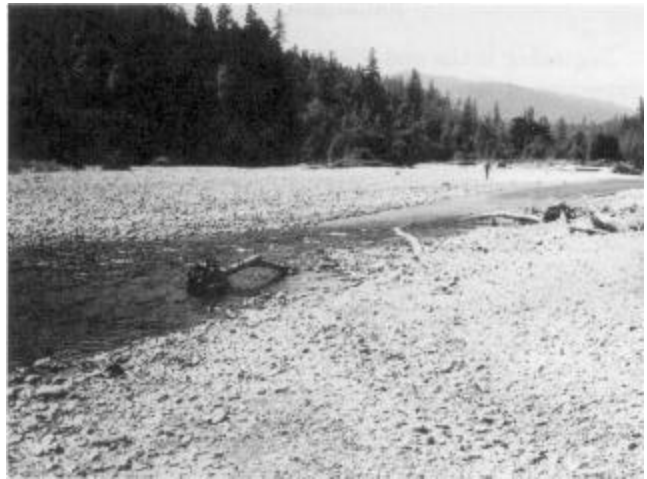
FIGURE 2. —Low-flow conditions along midbasin reach of Redwood Creek below mouth of Minor Creek. Photograph taken August 1975.

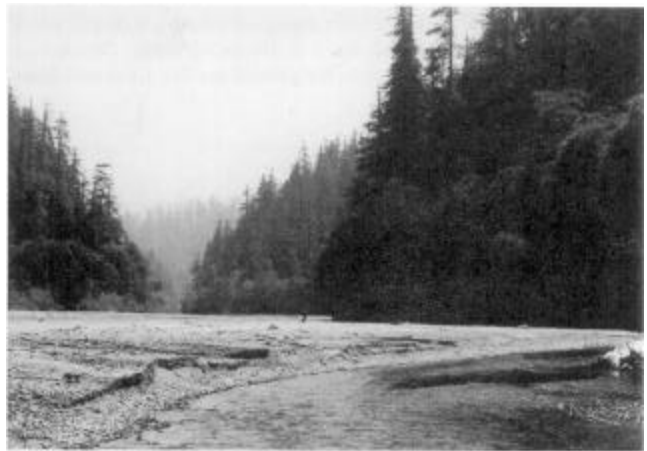
FIGURE 3. —Low-flow conditions along a lower reach of Redwood Creek near cross profile 3. Photograph taken August 1975.

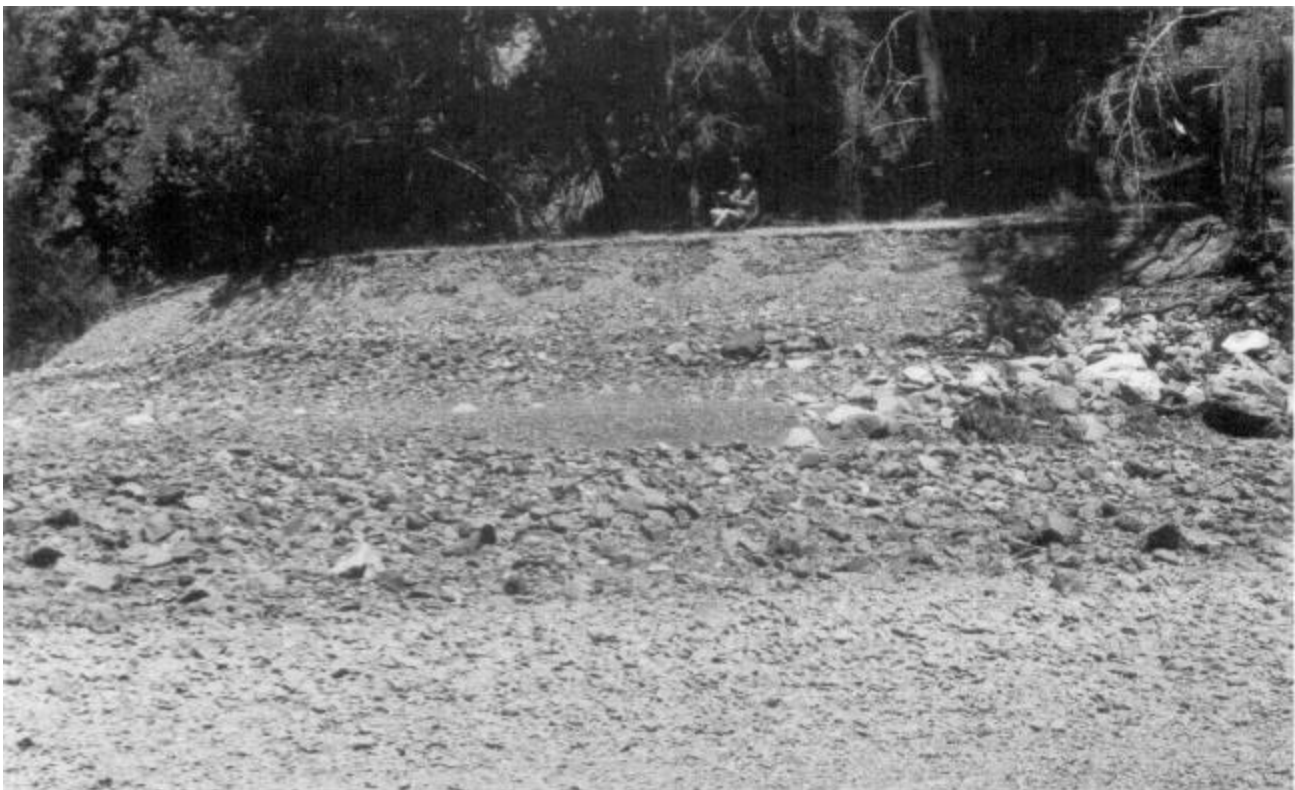
FIGURE 5.—Gravel berm deposited (along midbasin reach of Redwood Creek) during flood of 1972. Photograph taken August 1975.

Aerial photographs, botanical evidence, and interviews with local residents indicate that, although some changes began in the mid-1950's, the most dramatic changes occurred in response to major storms in December 1964 and March 1972 (Janda and others, 1975). The relatively minor changes observed by residents in the mid-1950's probably resulted from the flood of January 1953 and (or) the flood of December 1955. The locus of maximum erosion and deposition associated with the 1964 flood was concentrated in upper parts of the watershed, and that associated with the 1972 flood was concentrated in the lower part of the basin (Harden and others, 1978). Along upper Redwood Creek, stands of young conifers on flood-deposited gravel berms are even-aged and in 1984 were about 18 years old, suggesting that these berms are related to the December 1964 flood (fig. 4). Along downstream reaches, the ages of recently established conifers indicate that the flood berms in those reaches are primarily related to the 1972 flood (fig. 5).

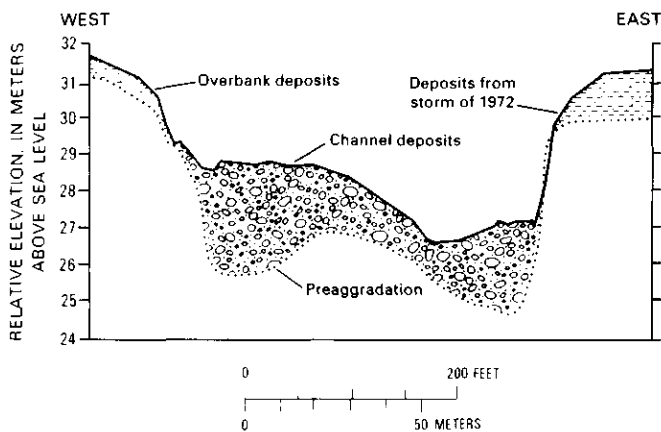
FIGURE 10. — Recent changes in the geometry of Redwood Creek at the mouth of Tom McDonald Creek. Preaggradation configuration was estimated from reports of local forest workers and road construction records. Configuration in 1972 is from ground surveys.

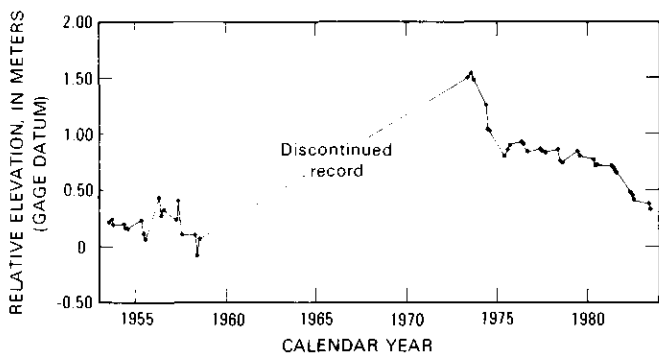
FIGURE 11.—Variation in mean elevation of the low-flow channel of Redwood Creek at the gaging station near Blue Lake (11481500). Mean streambed elevations were determined by using methods described by Hickey (1969).

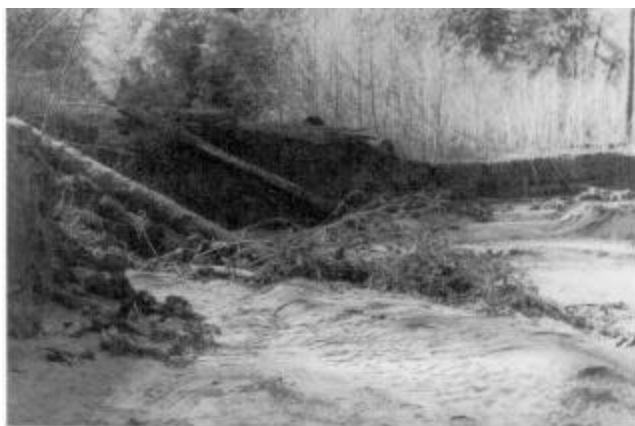
FIGURE 12.—Trees toppled by bank erosion immediately downstream of the Tall Trees Grove. Photograph taken March 1976.

The channel changes resulting from the floods of 1964 and 1972 had adverse impacts on riparian vegetation along many reaches. Bank undercutting toppled many old-growth redwood trees (fig. 12). Elsewhere, gravel deposition completely filled the former lower flood plain and spilled onto extensive areas of the former upper flood plain. This gravel deposition killed numerous trees,

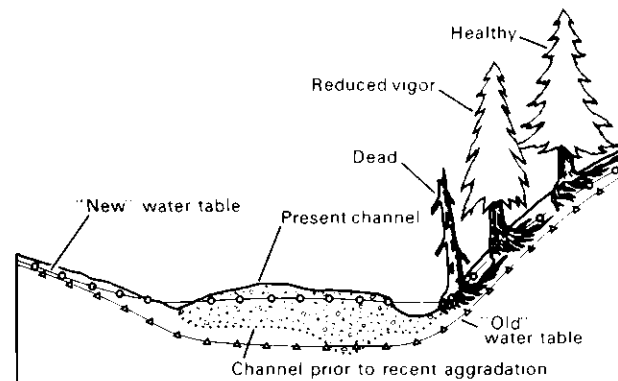
A. IMPACT OF STREAMBANK EROSION

B. IMPACT OF BURIAL BY COARSE-GRAINED SEDIMENT

C. IMPACT OF HIGHER STREAMSIDE WATER TABLE

FIGURE 13. —Schematic representation of observed impacts of channel aggradation on riparian vegetation.

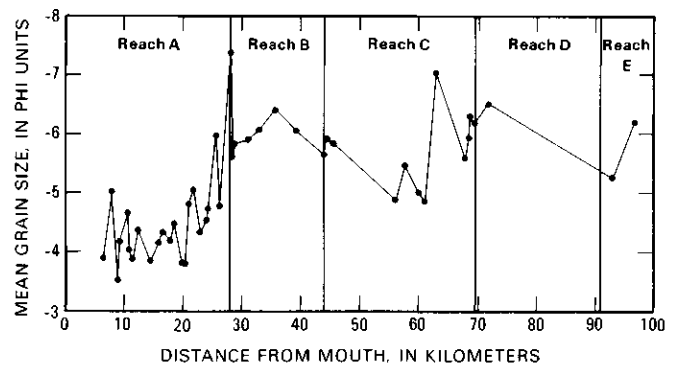
FIGURE 16.—Mean grain size of bed material at cross profiles during the summer of 1976.

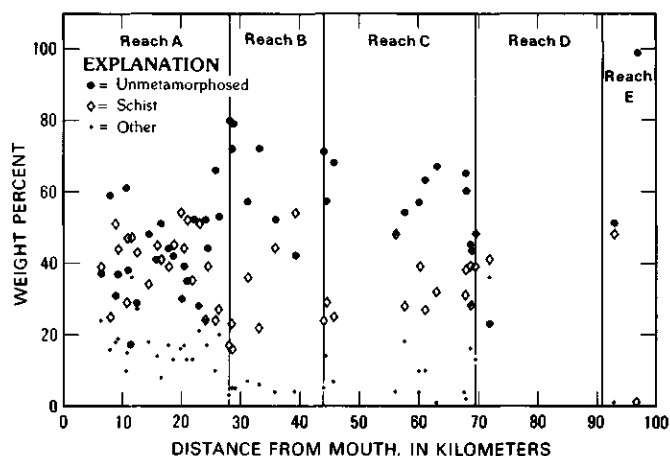
FIGURE 17. — Lithologic composition of bed material at cross profiles during the summer of 1976. "Unmetamorphosed" refers to conglomerate, sandstone, and mudstone clasts. "Schist" refers to schist and foliated metavolcanic clasts. "Other" refers to quartz and unfoliated greenstone clasts, and clasts too small for lithologic identification.

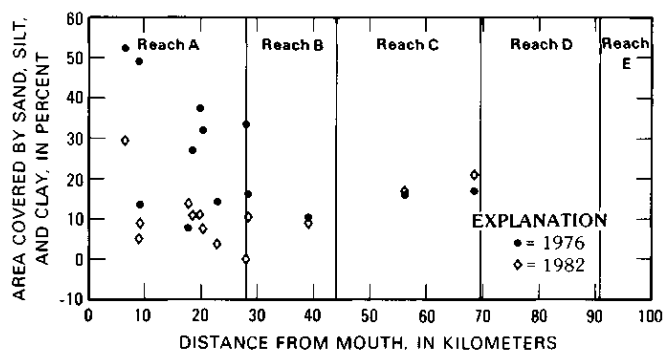
FIGURE 20.—Percentage of streambed area covered by sand, silt, and clay at selected cross profiles, summers of 1976 and 1982.

Mean grain size increased between 1976 and 1982 at 11 of the 13 cross profiles at which pebble counts were repeated (fig. 18). Increases in  $D_{16}$  were generally greater than in  $D_{84}$  (fig. 19), which suggests that the winnowing out of fine material was largely responsible for the increases in mean grain size. The selective removal of fine material is also suggested by the fact that, at 11 of the 13 cross profiles, the percentage of area covered by sand, silt, and clay decreased between 1976 and 1982 (fig. 20).

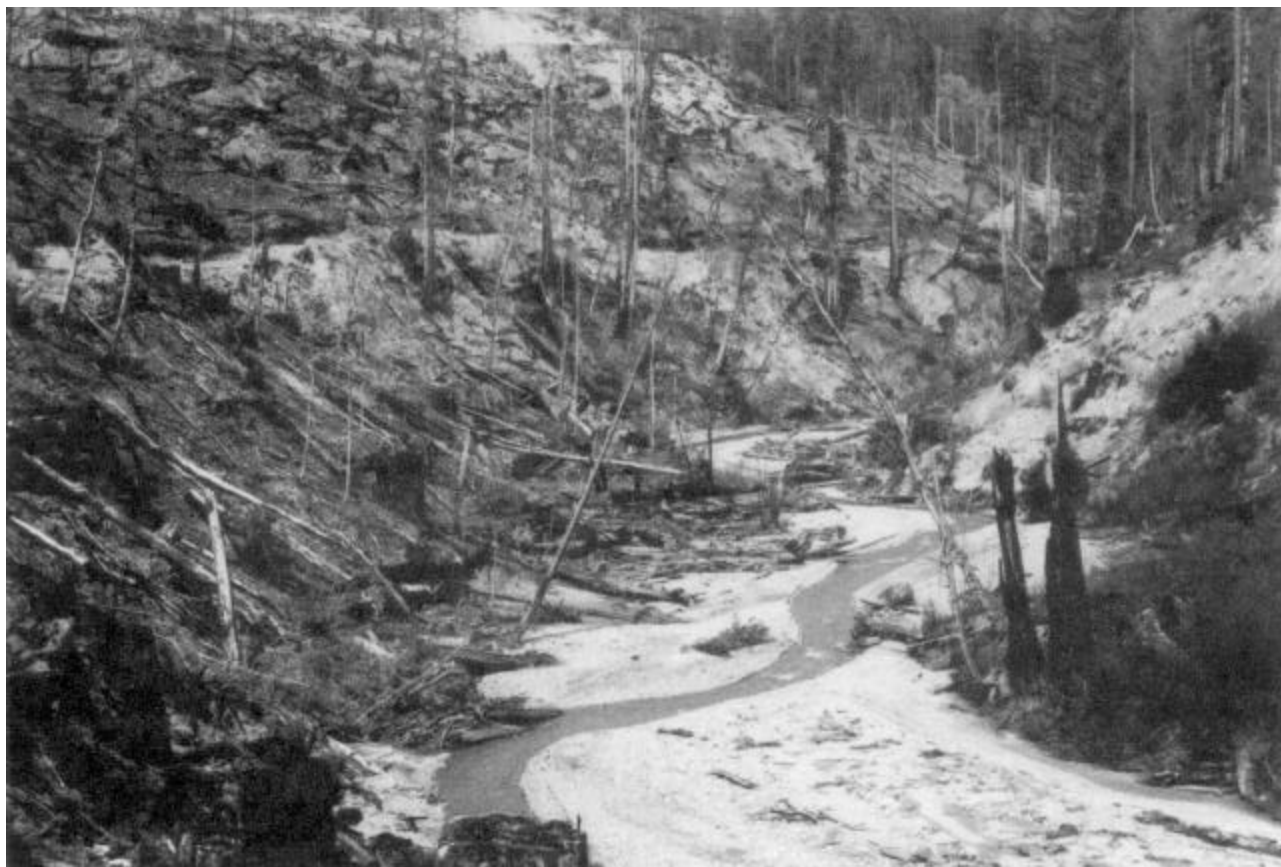
FIGURE 24.—Highly disruptive timber-harvest practices along lower reaches of Bridge Creek. Photograph taken April 1975.
